Confidential Inspection Report

Inspection Date:
January 12, 2015

Prepared For:
Joe Home Buyer

Prepared By:
360 Home Inspections
13325 Antonio Way
Dade City, Florida 33525

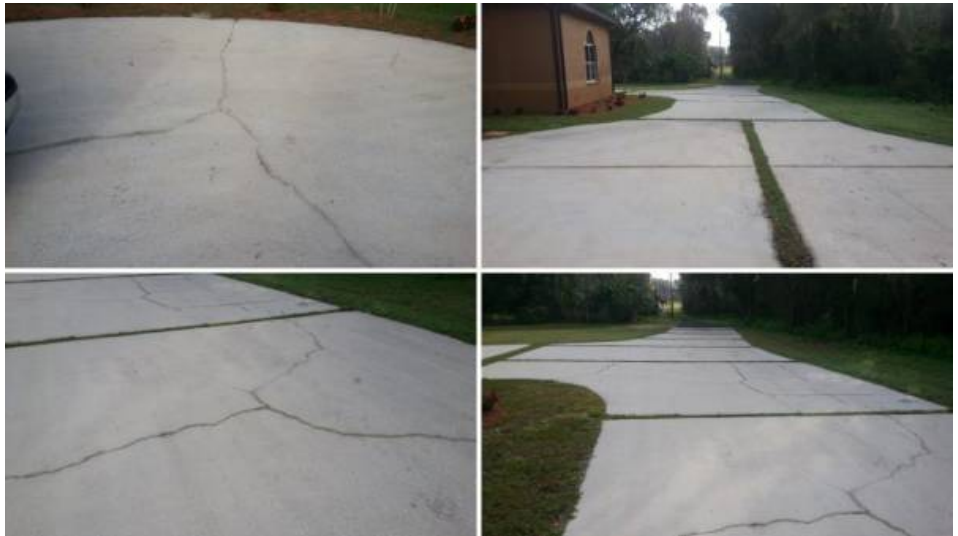
CONDITION: Driveway is in good condition. Cracks noted are typical.

IMPROVEMENTS/ROUTINE MAINTENANCE MINOR: Sealant recommended.

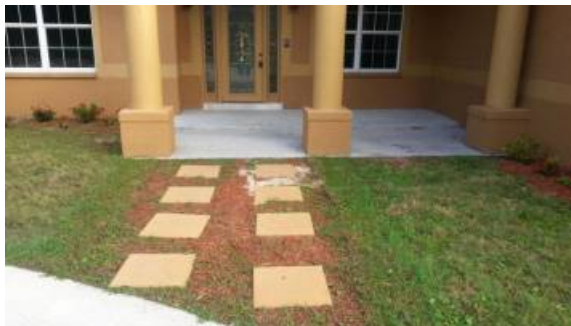
CONDITION: Sidewalk is in good condition.

IMPROVEMENTS/ROUTINE MAINTENANCE Tripping hazards may exist with these types of pavers. Suggest monitoring and making corrections as necessary.

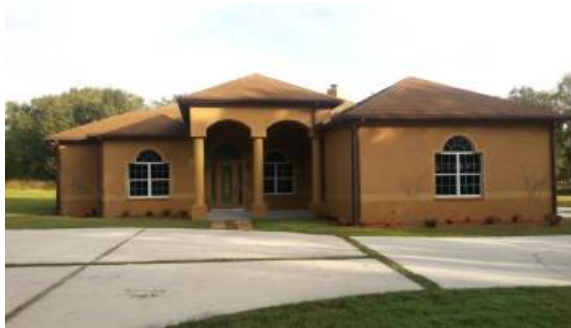
CONDITION: Good, Cracks noted - typical.

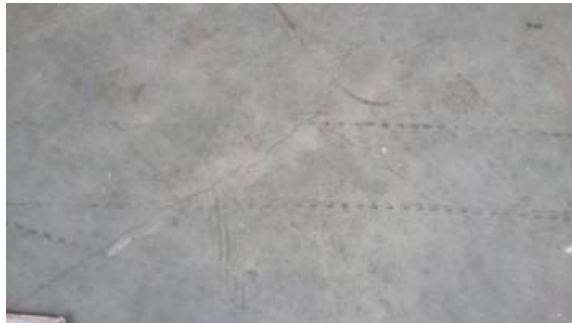
CONDITION: Good, Typical cracks noted. Monitor for enlargement or change and seek further evaluation in that event.

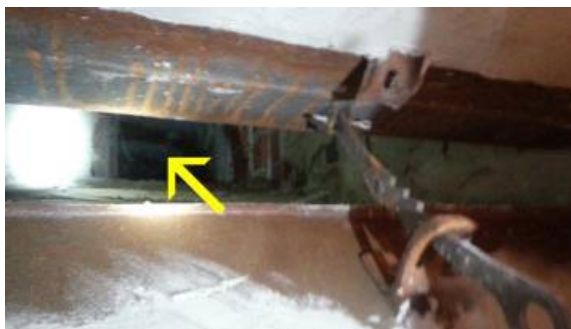
Cracks in stucco noted of exposed chimney on roof. Ceiling deck stain noted in attic below same location. Recommend further evaluation from a licensed roofing contractor to determine penetration points. Moisture meter read 17.5 which is at the low end of a high range for wood products.

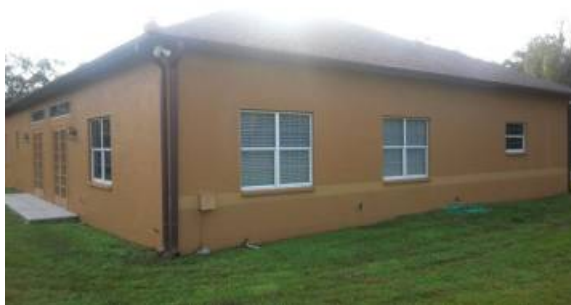
Some downspouts have the appearance to be draining into a below ground storm water drainage being carried away from the foundation however the flex drain terminates 2 to 4" below grade. Ground drain grates are also visible. Suggest checking with owner or contractor to determine purpose and intentions.

Downspouts should discharge at least 1 foot away from the foundation. Excess moisture near the foundation encourages insect infestation. Gutter leaks at joints.

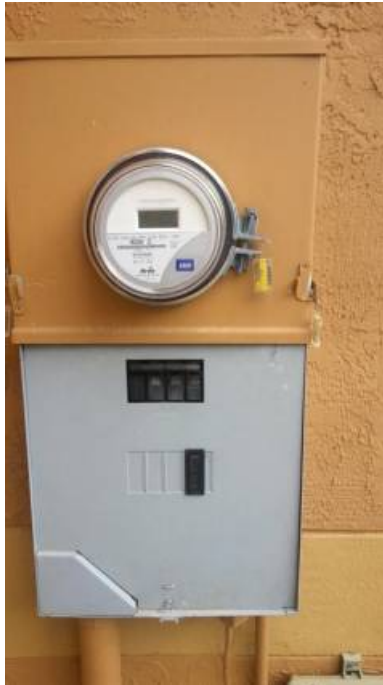
- MAIN PANEL DESCRIPTION:* General Electric main panel, 200 Amp Maximum capacity,
- MAIN PANEL REPAIRS:* Door is not secure to main breaker portion of box. Catch is broken.

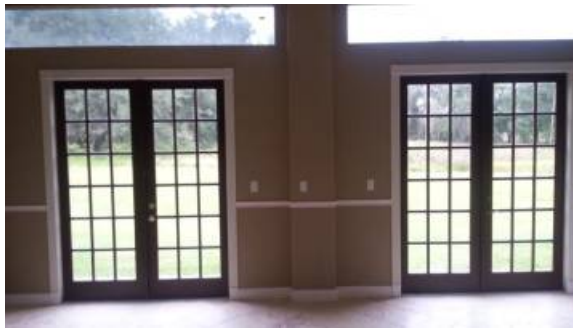
Door is still serviceable at this time but not without problems to proper operation. You should anticipate the need to replace it sometime in the future however. Adjustments are needed.

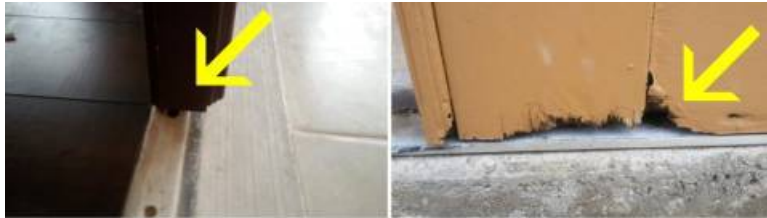
Some doors do not latch or latch to floor is missing at bottom of door(s) Sun room to master bedroom and family room.
Rot do to water damage noted on back wood doors.

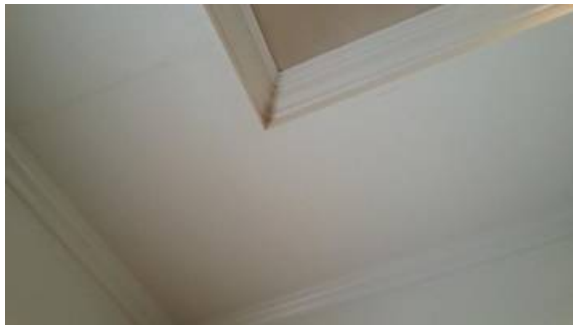
REPAIRS: Significant cracks noted at master bedroom N/W back corner of ceiling.

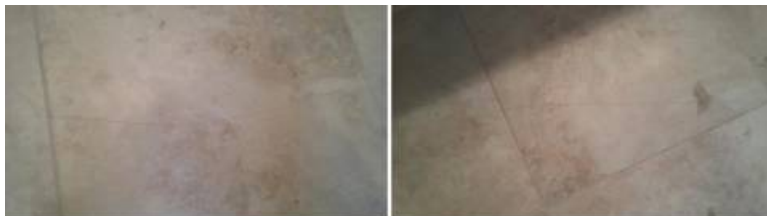
REPAIRS: Cracks noted in master bath tile floor by sinks.
