Confidential Inspection Report

Inspection Date:
January 12, 2015

Prepared For:
Joe Home Buyer

Prepared By:
360 Home Inspections
13325 Antonio Way
Dade City, Florida 33525

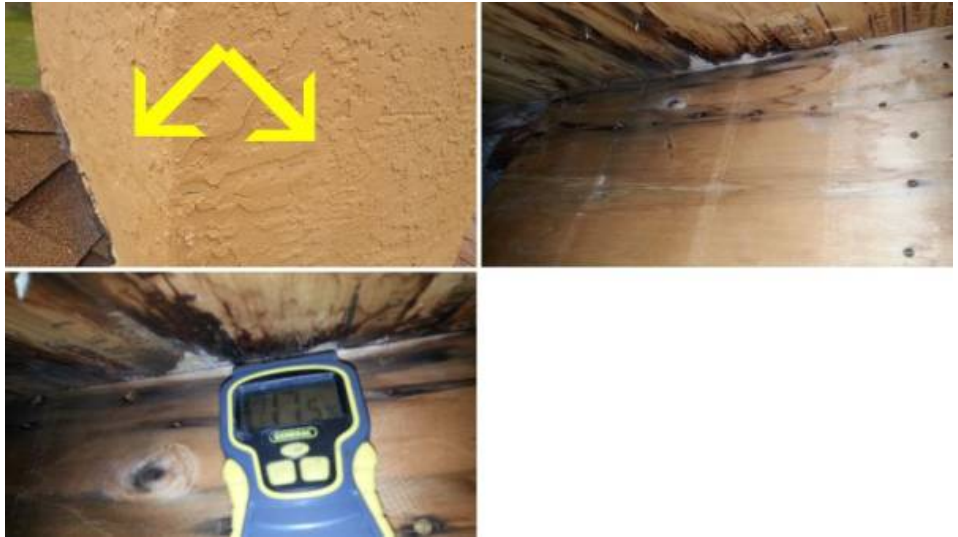
FURTHER EVALUATION:

Cracks in stucco noted of exposed chimney on roof. Ceiling deck stain noted in attic below same location. Recommend further evaluation from a licensed roofing contractor to determine penetration points. Moisture meter read 17.5 which is at the low end of a high range for wood products.

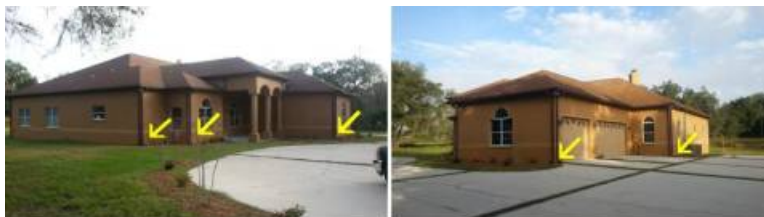
Some downspouts have the appearance to be draining into a below ground storm water drainage being carried away from the foundation however the flex drain terminates 2 to 4" below grade. Ground drain grates are also visible. Suggest checking with owner or contractor to determine purpose and intentions.

Downspouts should discharge at least 1 foot away from the foundation. Excess moisture near the foundation encourages insect infestation. Gutter leaks at joints.

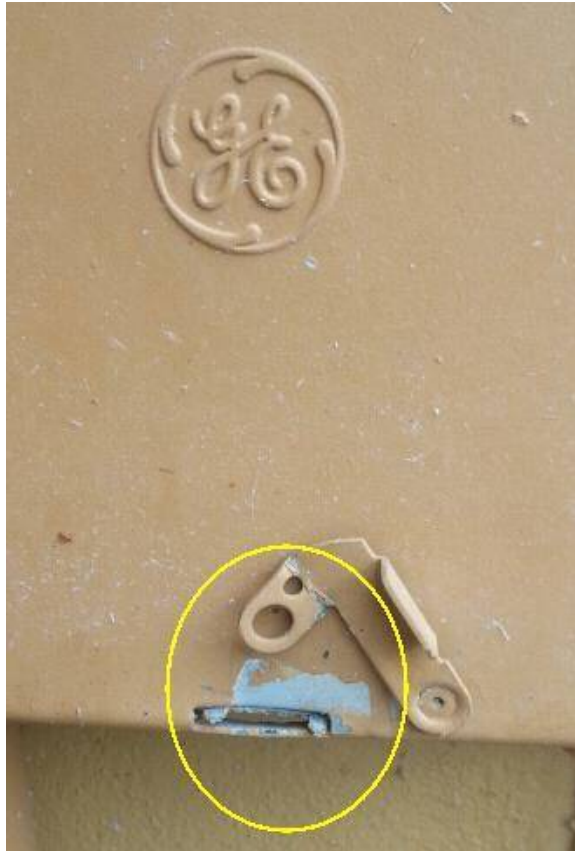
- MAIN PANEL DESCRIPTION:* General Electric main panel, 200 Amp Maximum capacity,
- MAIN PANEL REPAIRS:* Door is not secure to main breaker portion of box. Catch is broken.

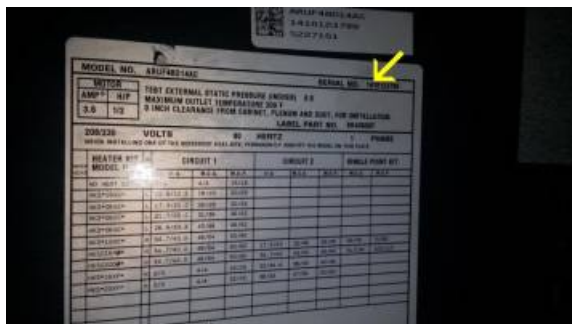
Heat responded to normal controls. Their is a metal secondary drain pan installed under the unit in case their is a drain problem with the unit.

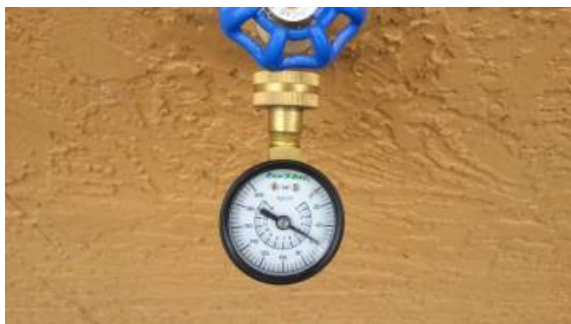
OPERATION: Sample operated, appeared serviceable
No anti-siphon found at any of hose bib outlets.
Pressure at hose bib: 58PSI.

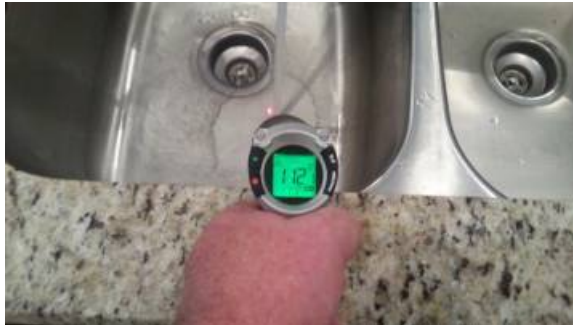
WATER TEMPERATURE AT FAUCET: 112 degrees
This is a little on the cold side. The recommended temperature for the hot water is between 114 and 122 degrees. This is usually accomplished by setting the thermostat(s) on the water heater at 125 degrees.
